TDK Life on Record Boombox Firmware Upgrade Instructions

Firmware Upgrade Procedure

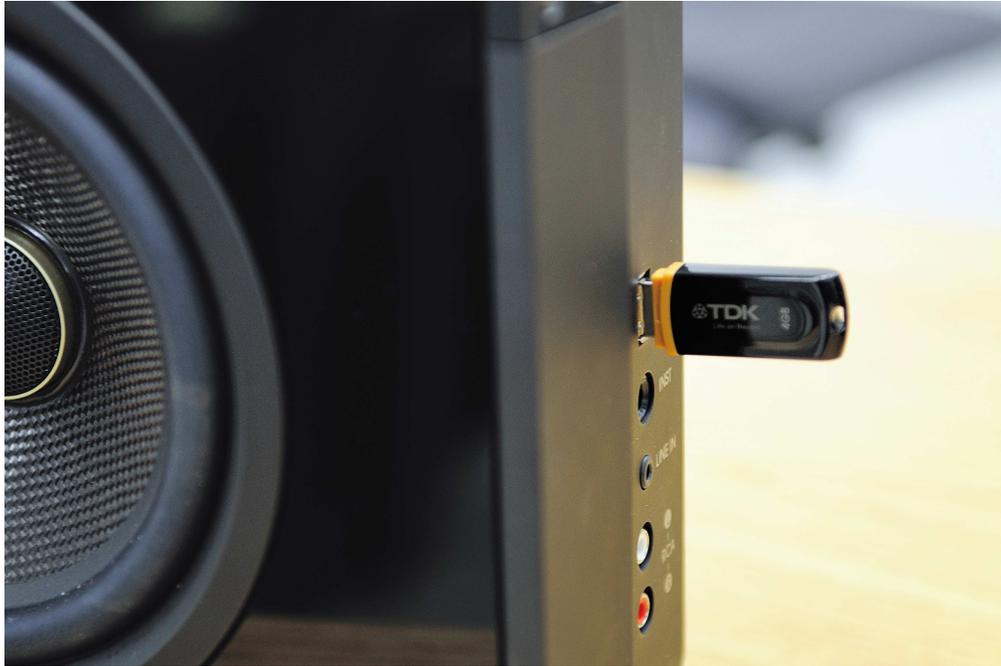
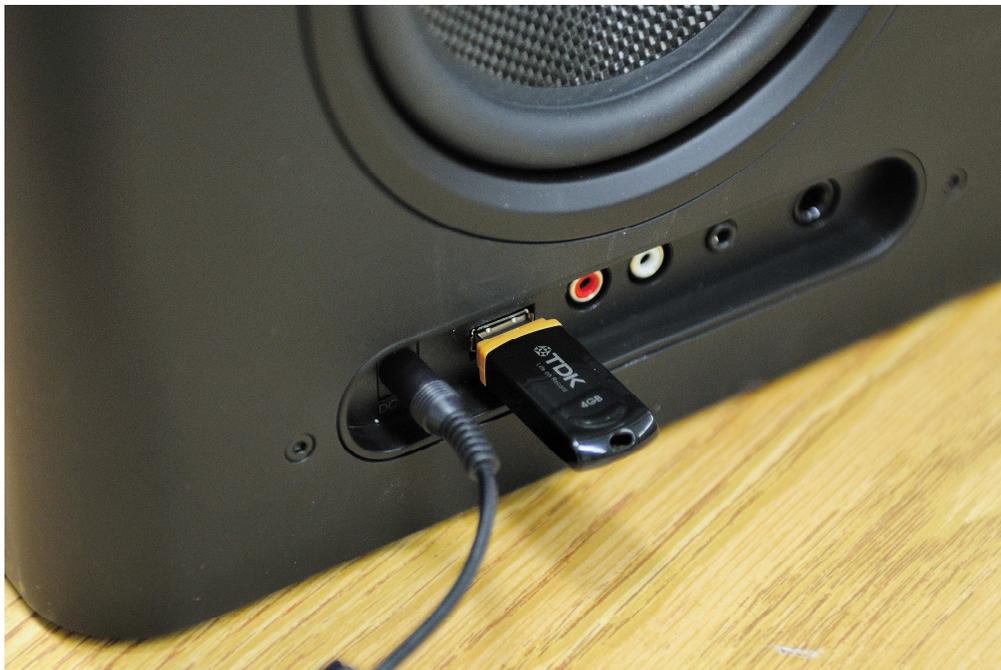
9. **IMPORTANT:** Remove all batteries from the unit if they are installed.
10. With the TDK Boombox turned OFF, locate the USB port on the side or back of your Boombox and plug the flash drive into the TDK USB port.

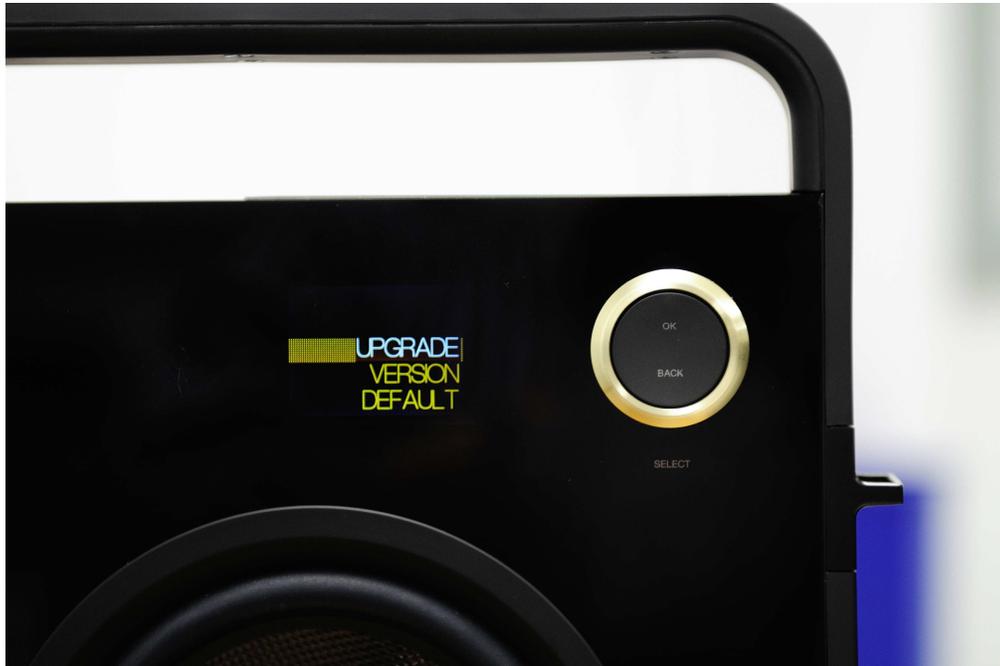
11. Turn on the TDK product while holding down the OK button to enter the diagnostic mode.
12. When the diagnostic menu appears, using the "Select" knob, choose UPGRADE, which is the first item in the list of options. Press OK.

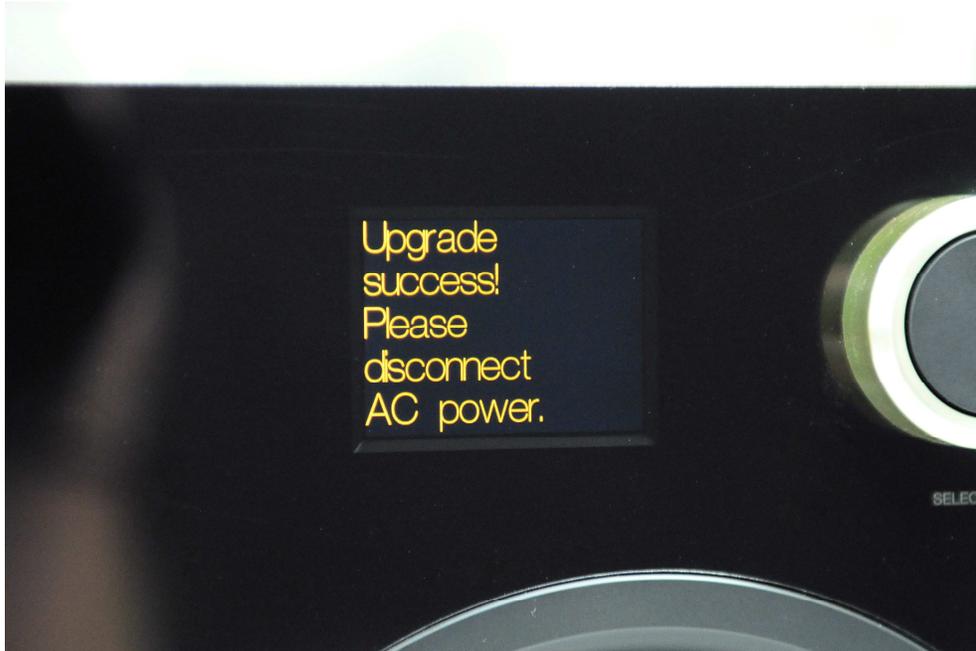
14. The firmware update will be read from the USB flash drive. The process will take approximately 15 to 20 seconds to complete.
15. After the firmware has been upgraded, the message "Upgrade success! Please disconnect AC power." will appear.

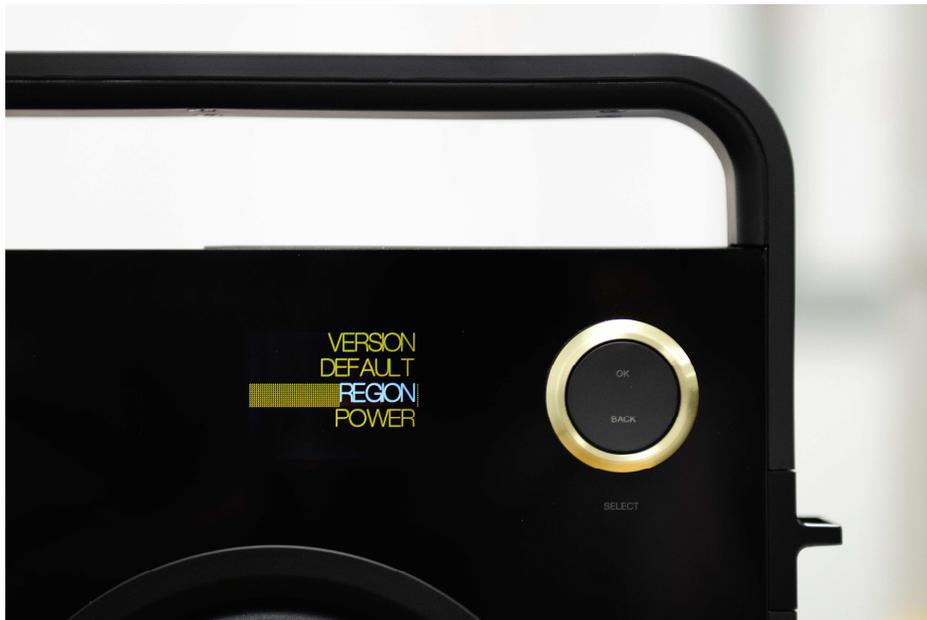
20. When the diagnostic menu appears, choose "REGION", from the list in the display using the "Select" knob. Then press OK.

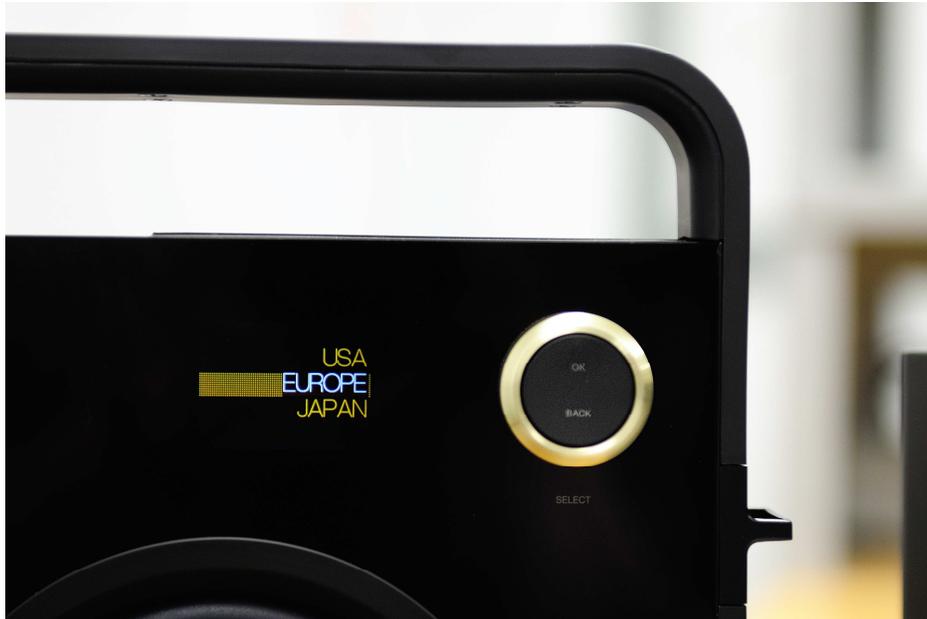
21. Select the desired region from the list: USA, EUROPE, or JAPAN. Press OK.
